Manhole Inspection Summary

Manhole # S23EE1002MH

Insp Date: **3/15/07 1:10 PM**

Location Address: **1401 41St ST**

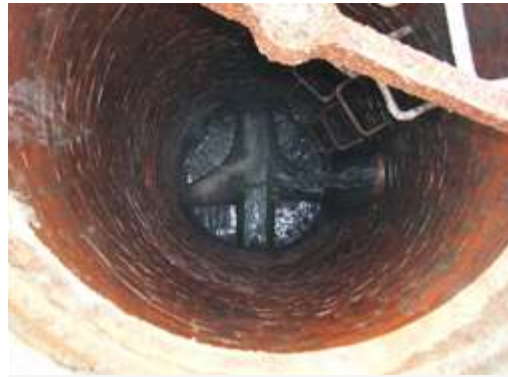
Top View

Corroded steps.

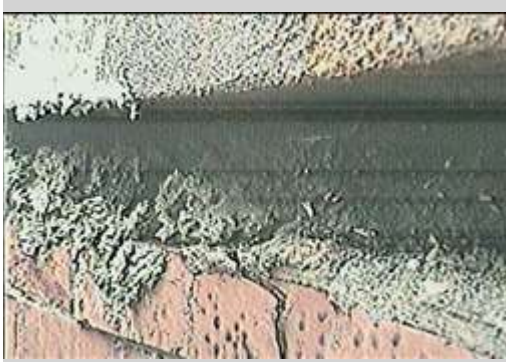
Defect

Adjustment deterioration, cracks and infiltration.

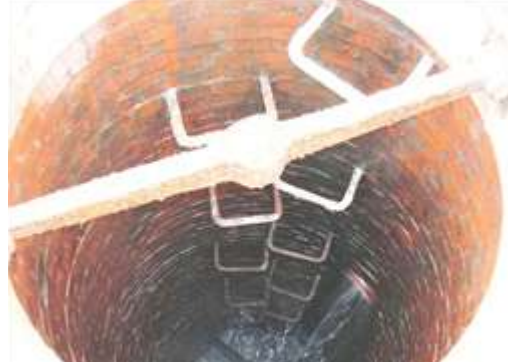
Defect

Frame leaks. Adjustment, Corbel and Barrel infiltration - other side.

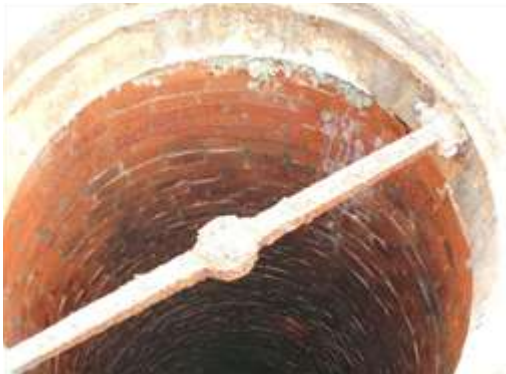
Defect

Frame leaks. Adjustment and Corbel infiltration.

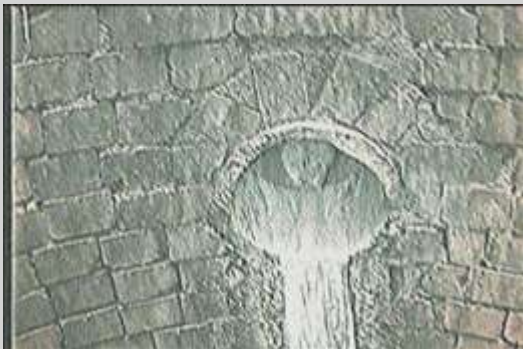
8 in. Circular Gravity Sewer Pipe In @ 3 O'Clock

Barrel deterioration and infiltration.

Infiltration: **Evidence** Pipe Seal Cond: **Unknown**

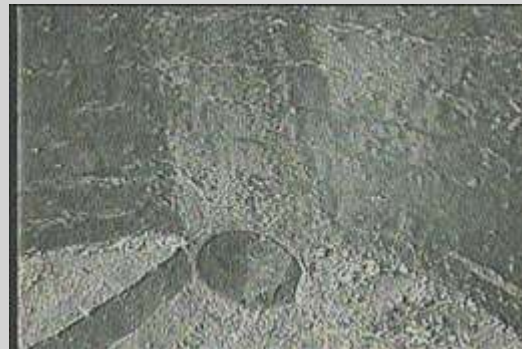
Drop In @ 3 O'Clock

Drop: **Outside** Rod and Bar
Angled: **Yes** Reading: **17.33** (ft.)
Inv Depth: **18.33** (ft.)

Drop Condition: **Clogged**

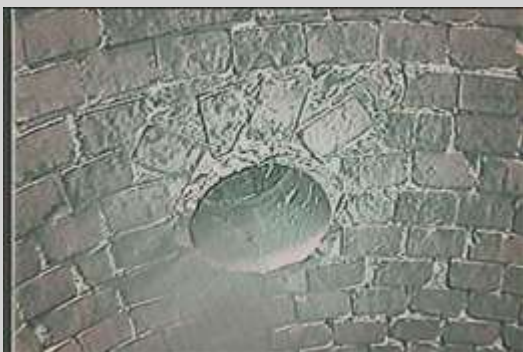
Pipe In @ 9 O'Clock

Infiltration: **Evidence** Pipe Seal Cond: **Unknown**

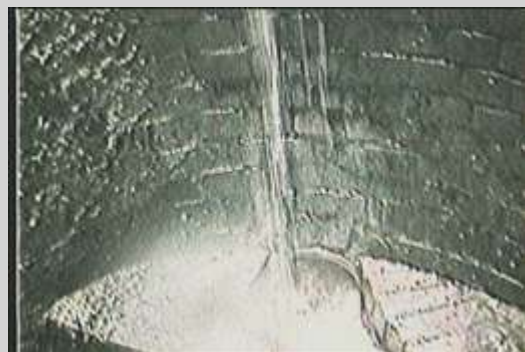
Drop In @ 9 O'Clock

Drop: **Outside** Rod and Bar

Angled: **Yes** Reading: **17.46** (ft.)

Inv Depth: **18.46** (ft.)

Drop Condition: **Partly Clogged**
